PAPER 12

Operating and maintaining a forgotten system: *The story of NMBM's bulk water maintenance*

Chandre Barnard

Deputy Director, Nelson Mandela Bay Municipality

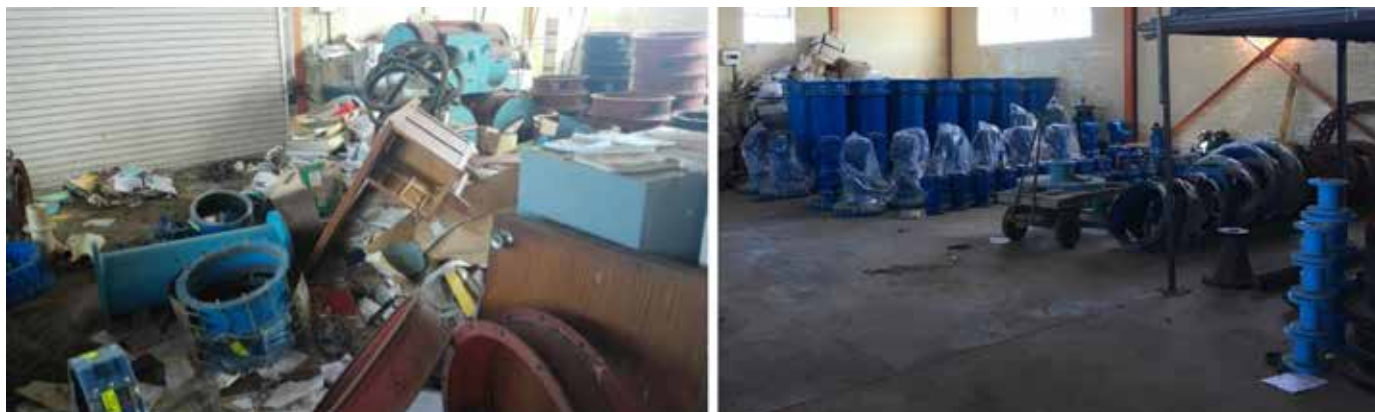
FIGURE 3: Before and after photo of the Linton store, inventory management, crucial to maintenance

The Linton Grange pipe yard is the main storage site for all Bulk supply materials. The storage building was however found to be in a state of utter neglect, used mainly as a place to discard unwanted clutter. This indicated a clear lack of system implementation, the storage space should indicate flow ability of work. A neglected storage space means that repair materials

Firstly the historic documentation was collected and put into archive, scrap and rubbish was removed and the entire space cleaned. A stock list was created based on repair methods of each pipe type under the division's responsibility and sufficient stock levels were procured for a minimum of at least two repairs for every pipeline at any given time. This ensures that repairs can be done almost instantly as there are no waiting times for materials. Repairs are also executed in a less stressful environment.

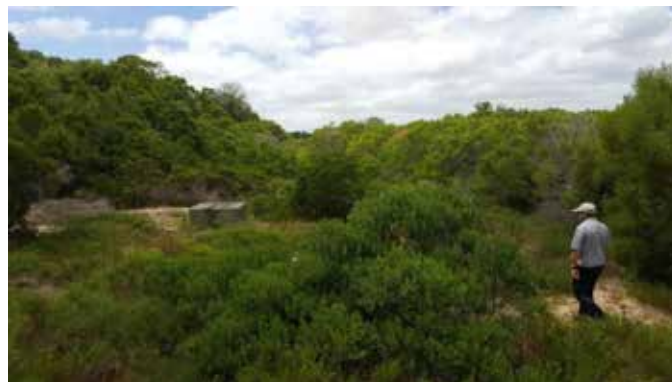
As previously mentioned the assessment can be put on hold depending on the access conditions. Certain sections of pipeline track have not seen a vehicle in almost 20 years. It is a wonder how these essential lifelines have been able to vitally serve the city whilst being completely forgotten about. Triennial bush clearing contracts are needed to bring the alien vegetation back to a manageable state, where maintenance teams can use basic equipment to keep the servitude clean.

FIGURE 6: The chamber on the left indicates pipeline location, almost disappearing in the bushes

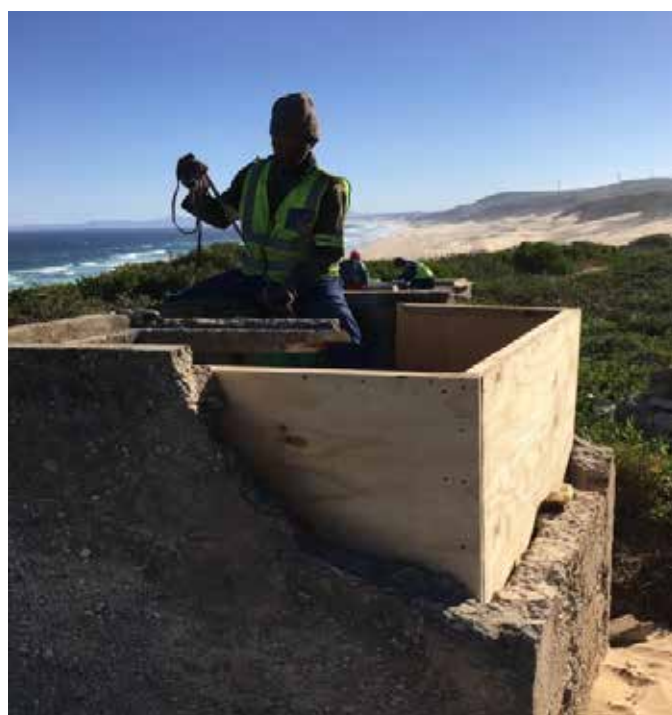
FIGURE 7: Repairing a broken chamber

Although access is essential, it must also be regulated. Vandals will strip valves and chambers of any metal they can. Servitudes as well as chambers must be locked at all times. Investigations indicated a large problem with open chambers, which required refurbishment contracts as per figure 7 and 8.

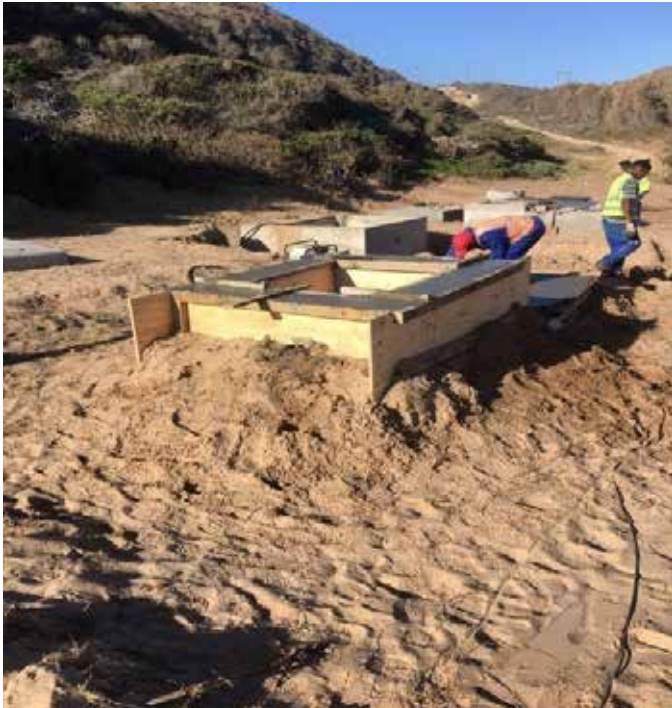
FIGURE 8: Raising a chamber submerged by a sand dune

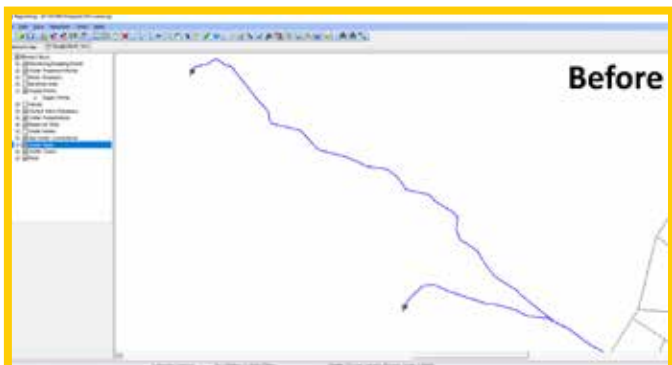
FIGURE 11: Before information was captured, only the pipeline location was available

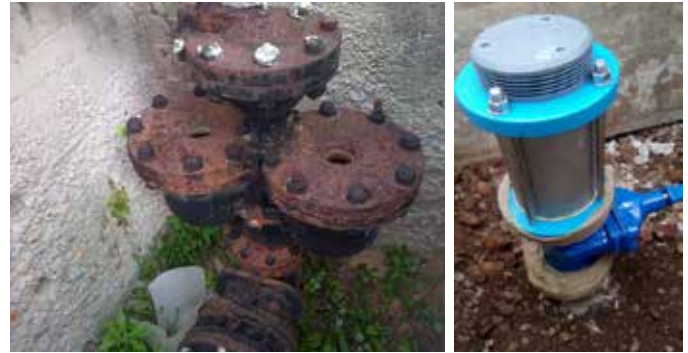
Figure 9 not only indicates neglected fittings but also a neglected chamber. The valve is badly corroded and the balls being “down” indicates that the valve is isolated and not performing its required function. The pipe is in danger. Wind erosion has damaged the chamber and undergrowth displays a lack of maintenance. Figure 10 indicates a newly replaced air valve, teams must now focus on maintaining this valve and chamber. Many

FIGURE 9: Air valve chamber

FIGURE 10: Newly replaced air valve

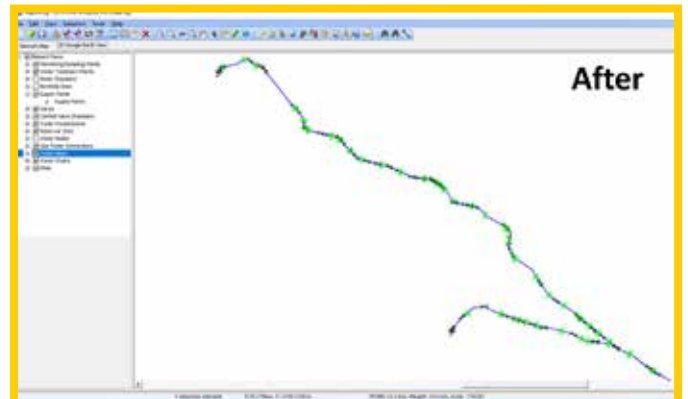
FIGURE 12: After capturing, pipeline is filled with detailed data including links to photographs
